## MEMORANDUM

**To:** Vulcan Coal Management Pty Ltd  
**Attention:** Gary Robertson, Andrew Bailie, Aromal Murali, Jamey Mitchelson  
**Prepared By:** Ty Grantham  
**Reviewed By:** Tom Sullivan  
**Date:** 15 June 2022  
**Memo Ref:** BMS-P21017C-VIT-VUL-M-5-V1.0  
**Subject:** June 2022 Quarterly Geotechnical Inspection – Jupiter and Dyno Pits

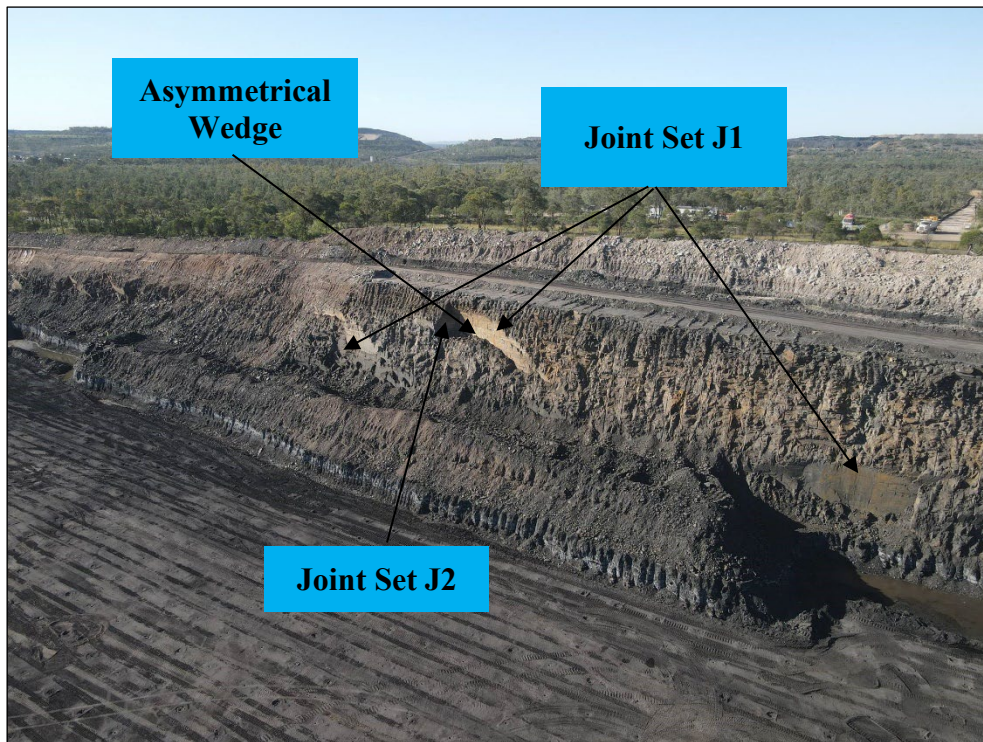
- Two joint sets, i.e., J1 and J2, were a prominent feature observed on the highwall. An asymmetrical wedge failure mechanism had occurred approximately in the central portion of the highwall, as shown in Figure 2-1. Cling-on material in front of the main failure plane had prevented this failure mechanism from forming completely. Therefore, there is the potential for further toppling and wedge failures and rockfall to occur. It was indicated that the failures had occurred after the rainfall event;

- A 15 m standoff and additional bund height was implemented to manage the wedge failure and toppling mechanisms, as shown in Figure 2-1;
- The approximate orientation, based on field mapping orientations, are as follows:

- Joint Set 1 (J1): 85°/050° (approximate dip/azimuth), and
  - Joint Set 2 (J2): 75°/185° (approximate dip/azimuth);
- Other toppling mechanisms were observed along the highwall face involving J1, as shown in Figure 2-2;

**Figure 2-1: Strip 5 (Looking North)**

- Strip 5 had been mined down to the DLL Seam. Preparations for blasting the thin stone band to the top of the DLLL Seam were ongoing;
- Joint sets J1 and J2 appear to be pervasive in Strip 5 and have resulted in the formation of an asymmetric wedge failure and numerous toppling configurations:

- J2 joints appear to intersect the highwall face obliquely and are unlikely to result in adverse planar or toppling kinematic geometries; however, is likely to form wedge failure geometries in combination with J1.

It is recommended that the current strategy of a 10 m exclusion zone from the slope toe line along with regular laser scan surveys are the most effective means of mitigating slope failure risks, particularly for the toppling mechanisms along the Strip 5 highwall. Increasing the exclusion zone up to 15 m for the larger failure mechanisms, such as the larger asymmetrical wedge mechanism (Figure 2-1), is also endorsed if required.

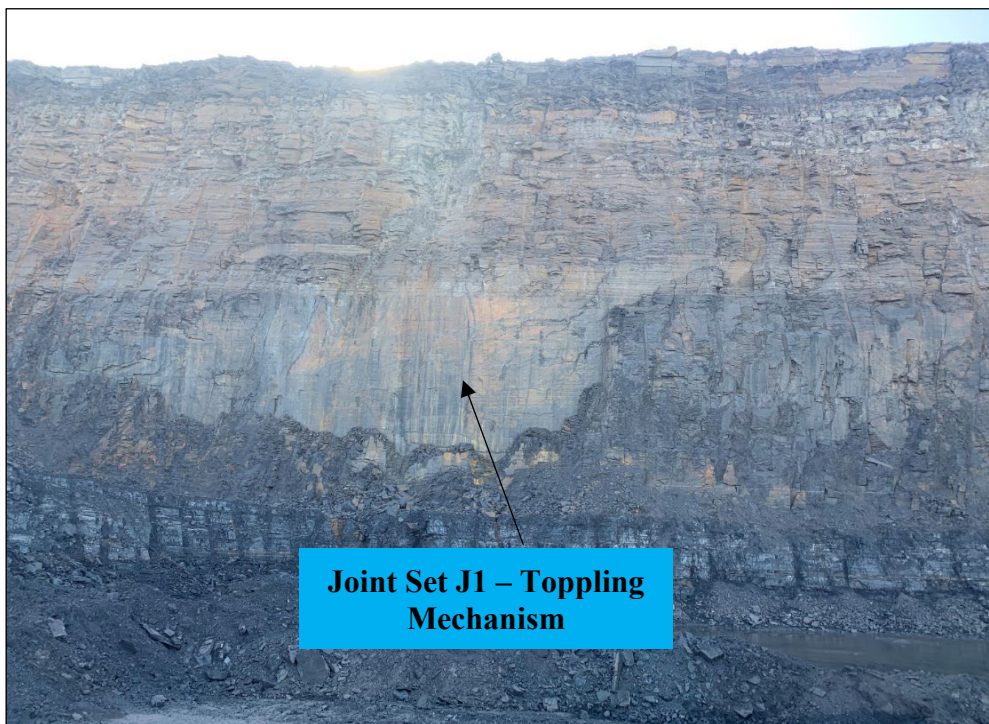
**Figure 2-2: Strip 5 Highwall Joint Structure (J1).**

- J1 joints are vertical to subvertical and have affected the pre-split blasting, resulting in some potential for rockfalls and toppling on the highwall; and

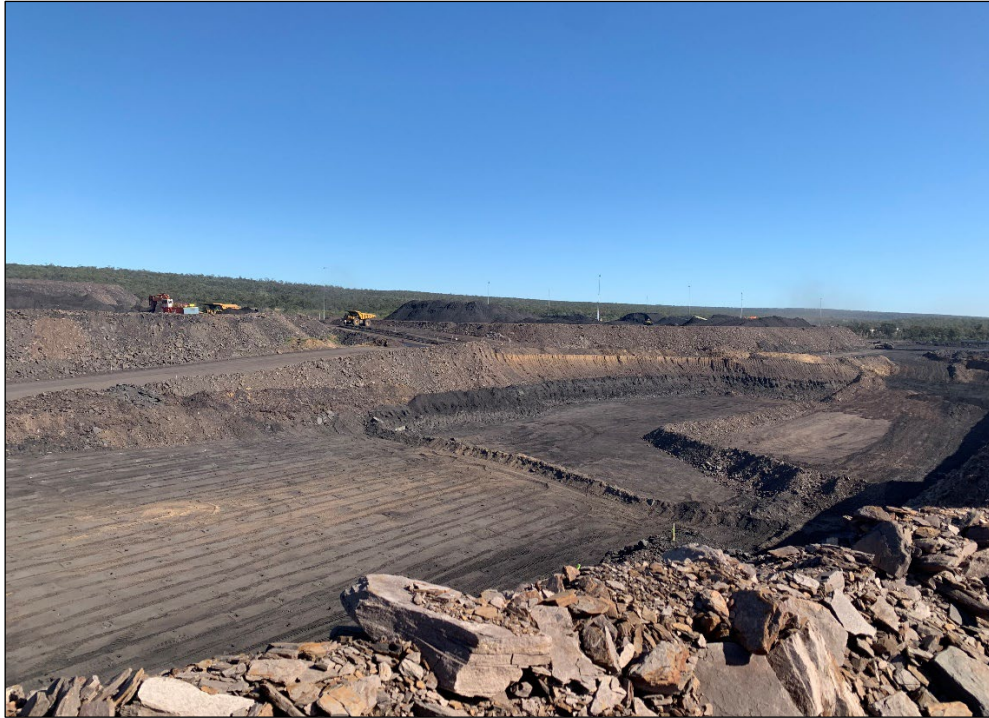
- No cracking was observed behind the highwall crest; and
- No stability issues were observed along the lowwall, as shown in Figure 2-3.

**Figure 2-3: Strip 5 Lowwall (Looking Northwest)**

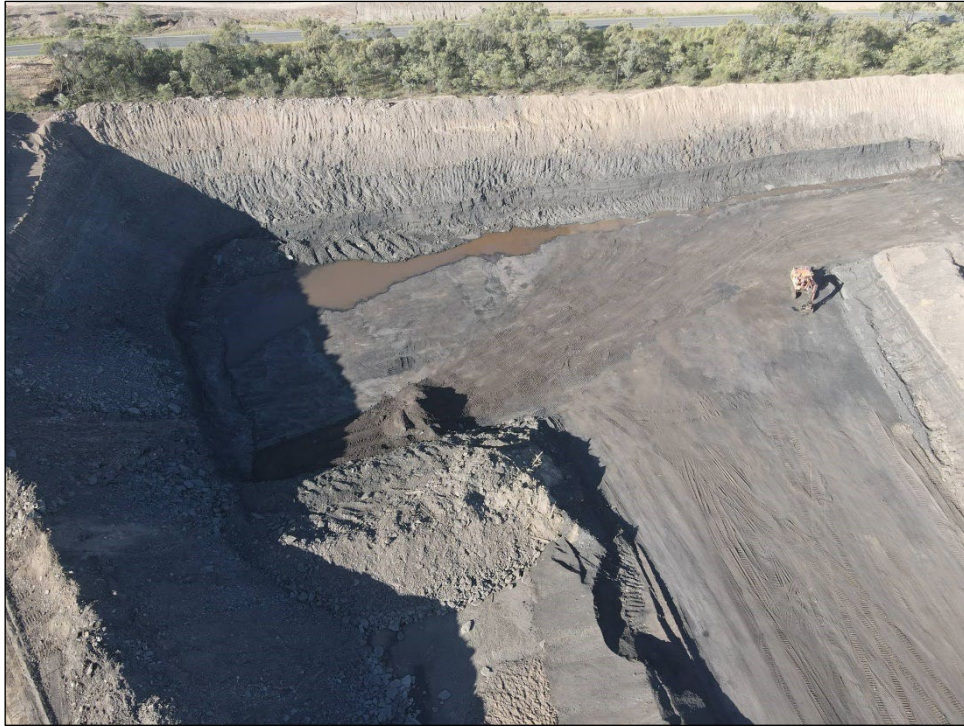
- Generally, no significant slope instability was observed in Strip 6;
- It was noted that the Tertiary horizon thickens in this area, and some possible minor oversteepening of the Tertiary towards the south of the pit had occurred, as shown in Figure 2-4; and
- Surface water was observed in the northern corner of pit.

**Figure 2-4: Strip 5 Lowwall (Looking East)**

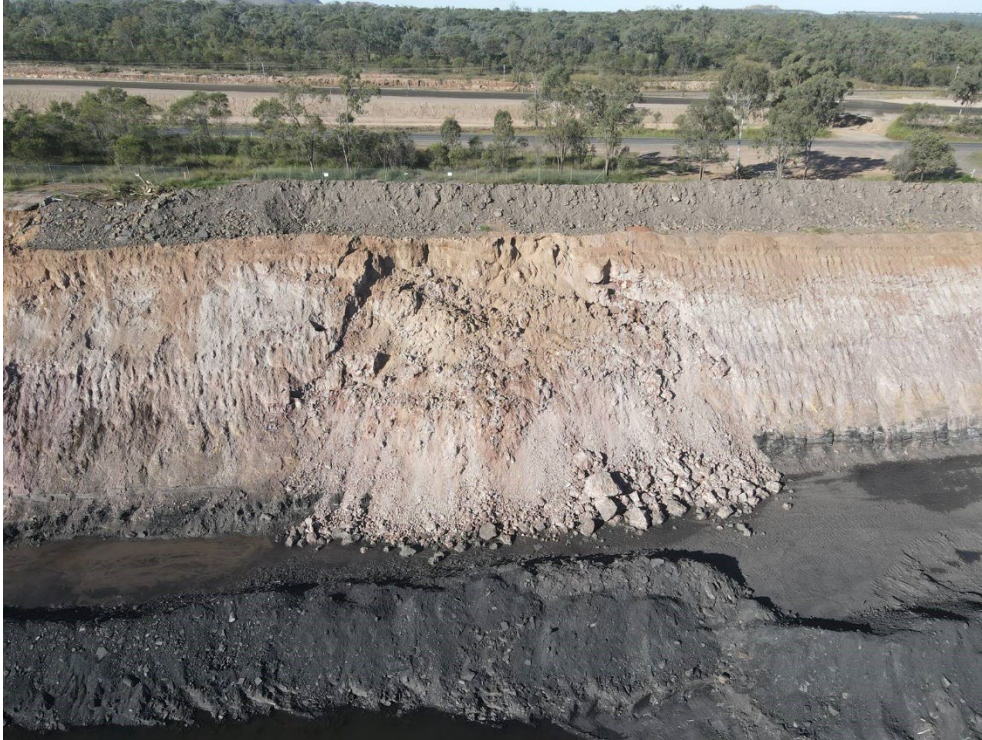
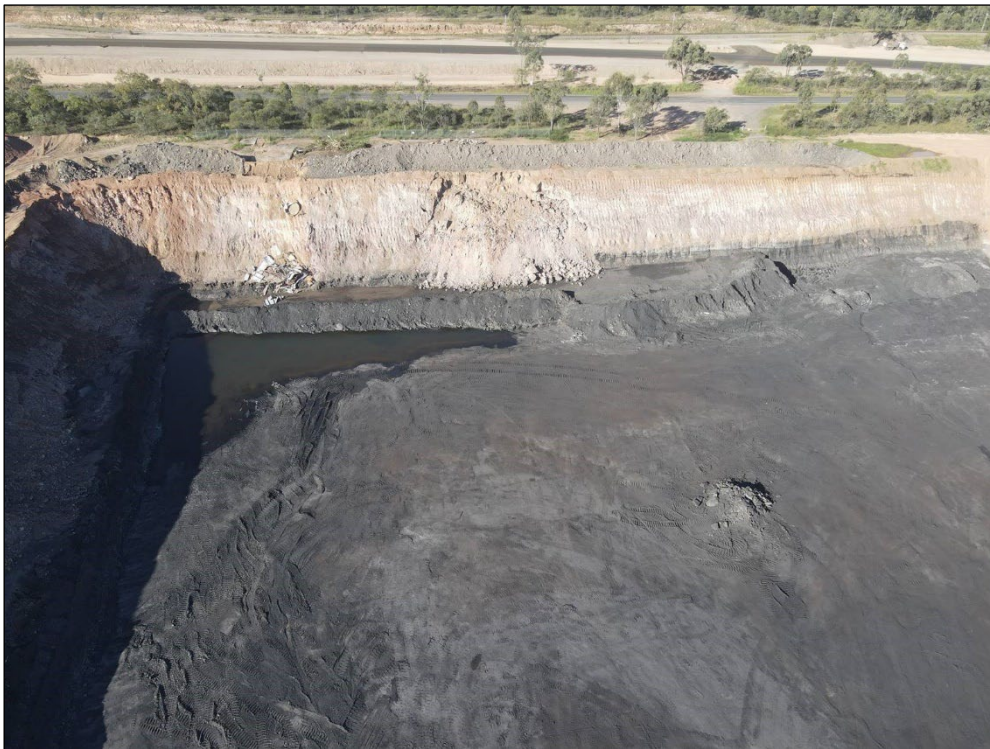
- A bench-scale slump in the upper Tertiary horizon was observed, as shown in Figure 2-5 and Figure 2-6. It was indicated by the OCE that the failure occurred approximately 48 hours after the significant rainfall event in the region several weeks earlier;

- From the aerial photos, it is likely that drainage behind the crest would not have been suitable to facilitate the flow of water away from the crest during the rainfall event. In this case, ponded water behind the crest and subsequent infiltration would have contributed significantly to the failure. As noted in the OCE report, ponding of water was noted behind the highwall;

- The Tertiary horizon in this part of the mine was approximately 10 m thick, and it was noted from the pit floor observation level that the batter was potentially slightly over steepened; and

**Figure 2-5: Dyno Pit – Highwall Slump – Aerial Photo**

**Figure 2-6: Dyno Pit – Highwall Slump – Aerial Photo**

- Antecedent rainfall was likely the driver of the Tertiary horizon failure in Dyno Pit. Additionally, the slope in this upper horizon may have been slightly over-steepened;

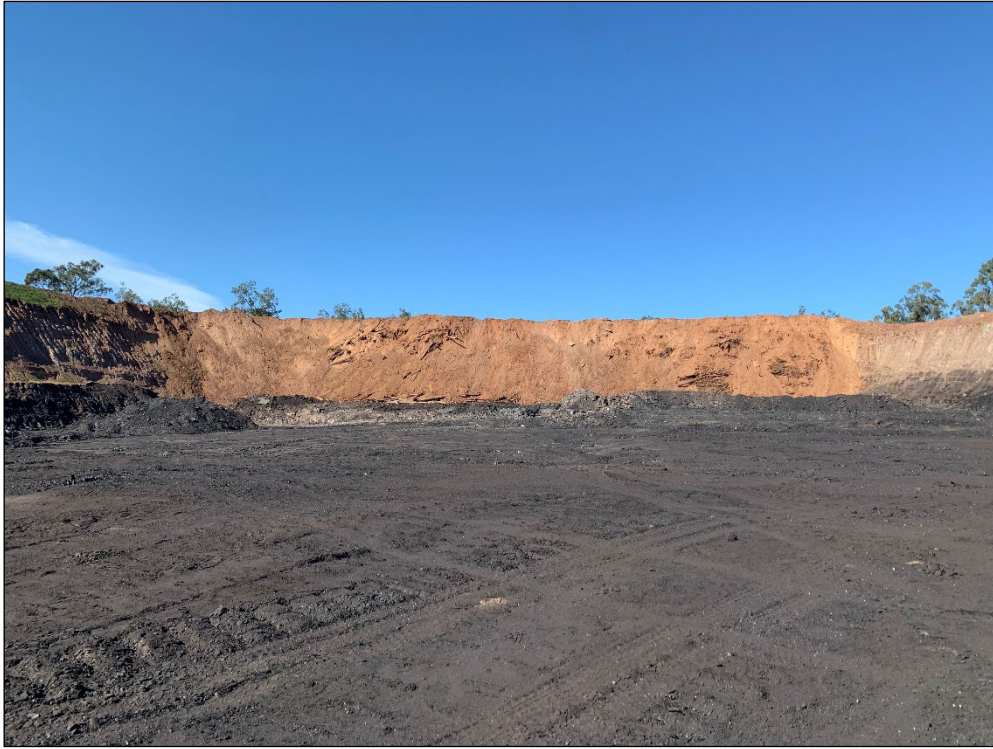
- Backfilled topsoil at the southern end of the pit appeared to be stable, as shown in Figure 2-7.

**Figure 2-7: Dyno Pit – Topsoil Backfill**

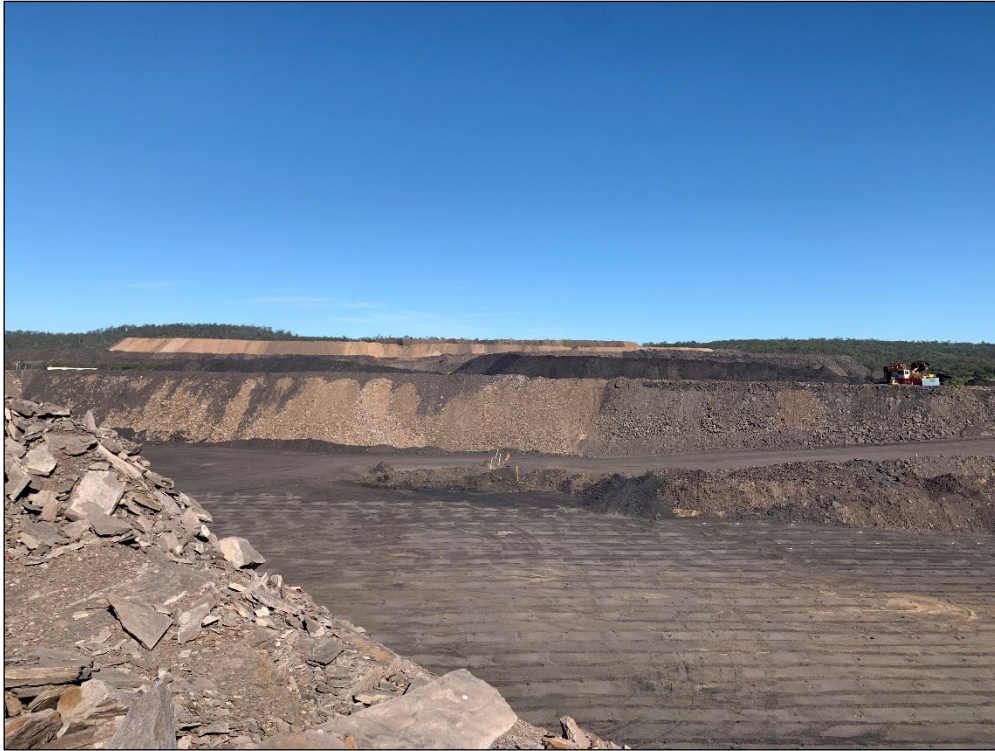
There were no geotechnical stability issues observed or noted from the external spoil dumps, as shown in Figure 2-8. It was noted that the upper dump bench was at RL 275 m, which is at the maximum height.

Inspection of the dumped material indicated primarily Category 2 to 2.5 spoil, with some spoil piles up to Category 3 to 4, in accordance with the Simmons & McManus (2004) framework.

It was indicated that some ponding of water was observed after the rainfall event and these areas were pushed down to allow the water to drain.

**Figure 2-8: External Spoil Dump**
