## INDUSTRY SAFETY AND HEALTH REPRESENTATIVE INSPECTION REPORT

| NAME OF MINE: | Vulcan Mine |
| INSPECTION DATE: | 31 <sup>st</sup> May 2022 |

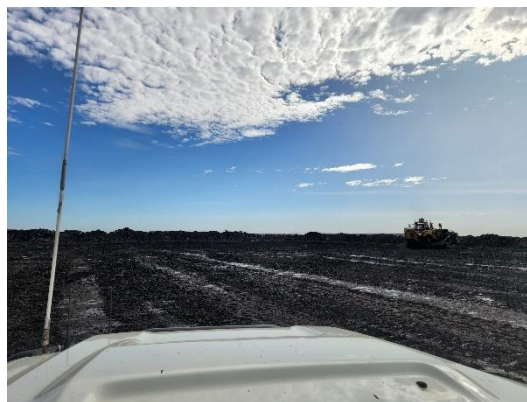
- Jupiter Bulk Sample pit depicted the geological issues in the wall.
  - The misfire
  - OCE McIver explained at times while mining a slight smell of Hydrogen sulphide ( $H_2S$ ), but no readings on the gas detector.
  - Partings were being dumped in pit; these partings contain Carbonaceous material.
- The go line, where OCE McIver explained how the park up (formula 1) go line worked.
- Dyno Pit, partings were being loaded out. OCE McIver explained the purpose of the 10-meter standoff bund in place.
- Dump 275 RL, where it was at its final RL. Some of the bunding was below the required 180m height.
  - The road on the entrance to the dump is rough and blown due to water crossing.

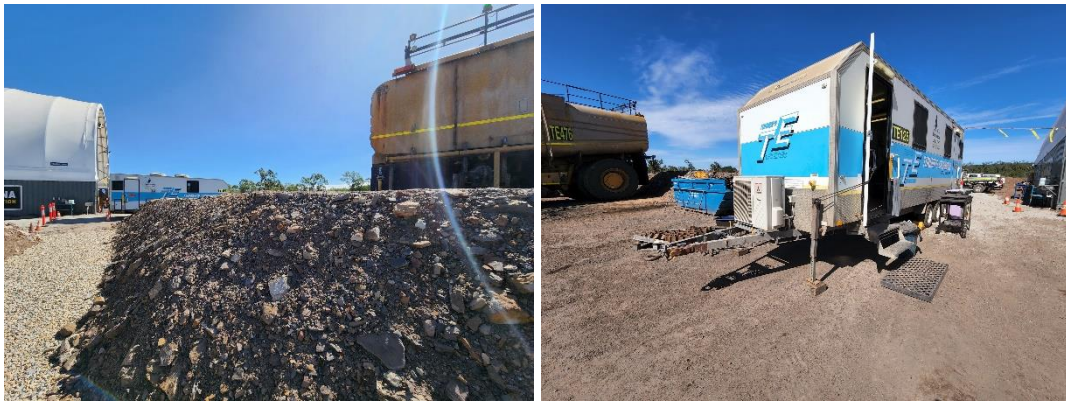
- As we approached the workshop, I noticed the park up area of heavy vehicles and the associated bunding. I made inquiries into whether the bunding would be adequate to protect persons in the event of a tyre event after being struck by lightning. Considering the walkway access behind the park up area

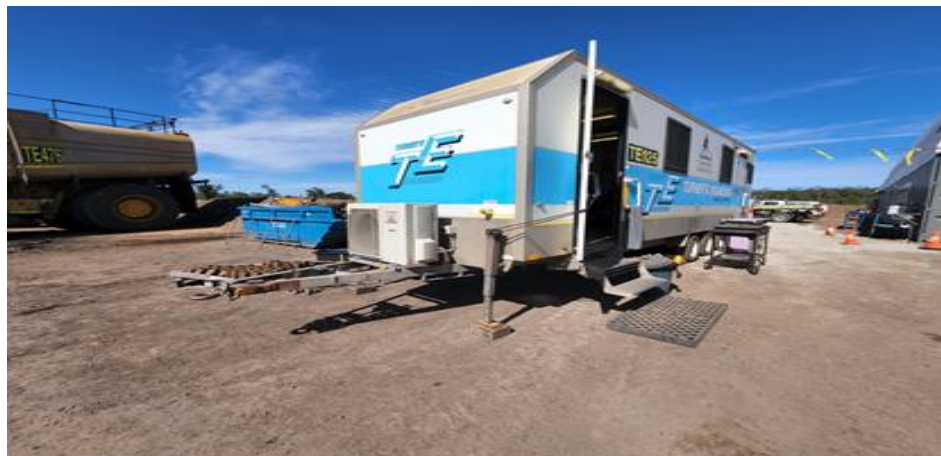
- I inquired to the requirements of having the mobile crib hut secured as it was not secured. I was later informed that the crib hut was at the workshop to rectify a potential air conditioning fault. It was clear that the crib hut was set up and being used.

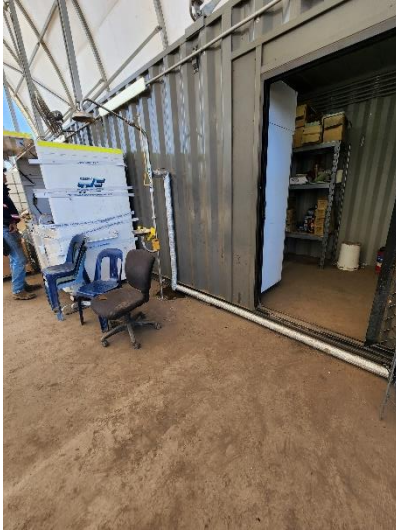
- A newly installed combination eyewash station and drench shower, access was obstructed with chairs. Signage needs to be erected to identify and demarcate the place of combination eyewash station and drench shower

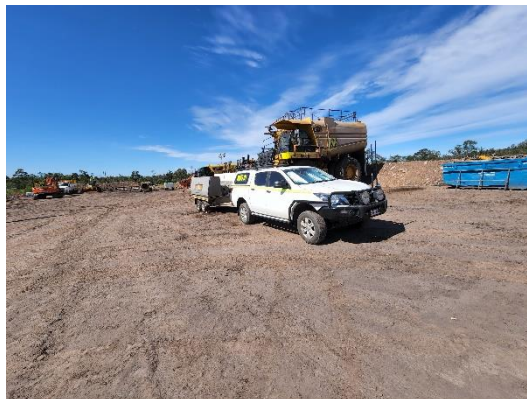
- A light vehicle and trailer were observed to be parked adjacent to the heavy vehicle park up area. We checked to see the both the light vehicle and trailer, were able to identify that they had completed the introduction to site process. We were unable to ascertain whether they had been under went the introduction to site process. It was explained that a register exists and all vehicles requiring access to operating areas are required to undertake the introduction to site process. Stickers for vehicles have purchased and are a new addition.

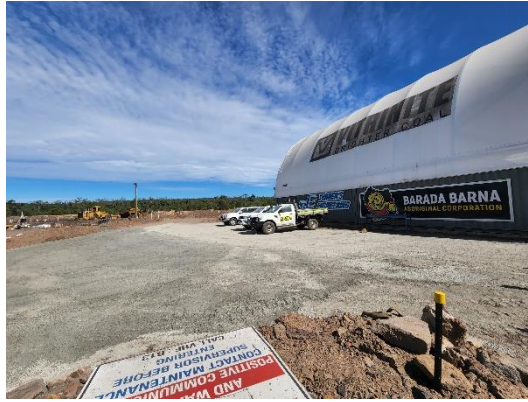
- In the light vehicle park up area, it was noticed that a vehicle may not be parked to the mines requirements of being fundamentally stable. It was explained that his area had just been remediated. The area needs to provide for vehicle to be able to park fundamentally stable.

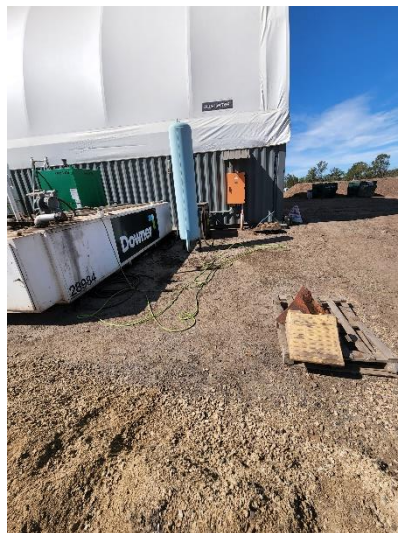
- Housekeeping throughout the area could have been to a better standard.
