| Mine Name | Mine ID | Operator | Activity Type | Activity Date |
| Vulcan Mine | MI04148 | Vulcan Mine<br>Management Pty Ltd | Inspection | 12/01/2022 |

## Mine Record Entry

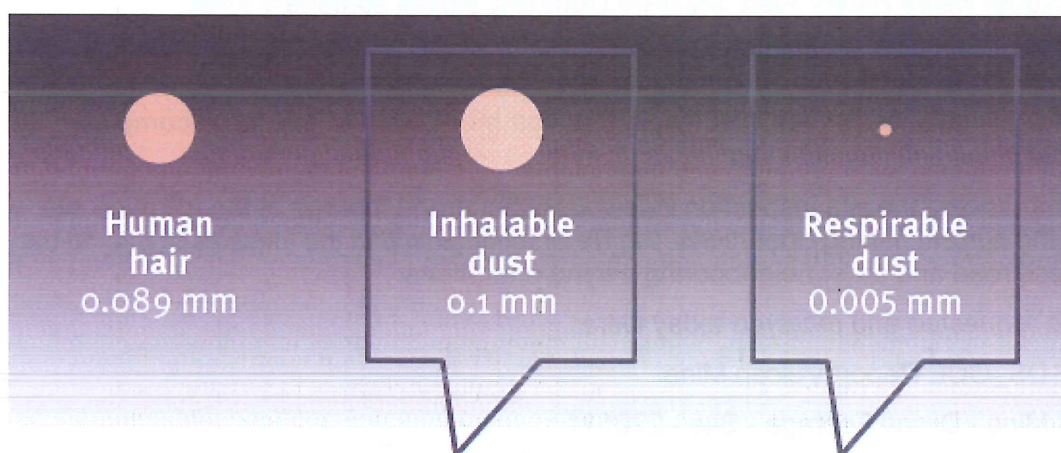
While at the Drill I provided the operator with an explanation of the risk both Inhalable and respirable dust presents to CMWs. Respirable dust (in particular silica dust) presents the higher risk. See extract of the RSHQ Pocket Guide booklet below for illustration.

| | Inhalable dust | Respirable dust |
| Size | Dust particles of all sizes (typically less than 0.1 mm diameter) | Smallest dust particles (typically less than 0.005 mm diameter) |
